Appendix E-6

Geotechnical Due-Diligence/Feasibility Assessment

October 18, 2021
P.N. 21-303

Subject: Desktop Geotechnical Due-Diligence/Feasibility Assessment, Mesa Verde Project, Approximately 1,492 Acres West of the I-10 Freeway, Adjacent and South of the San Bernardino/Riverside County Line and Approximately One-Mile North of San Timoteo Road, Revised Tentative Tract Map 33931, City of Calimesa, Riverside County, California

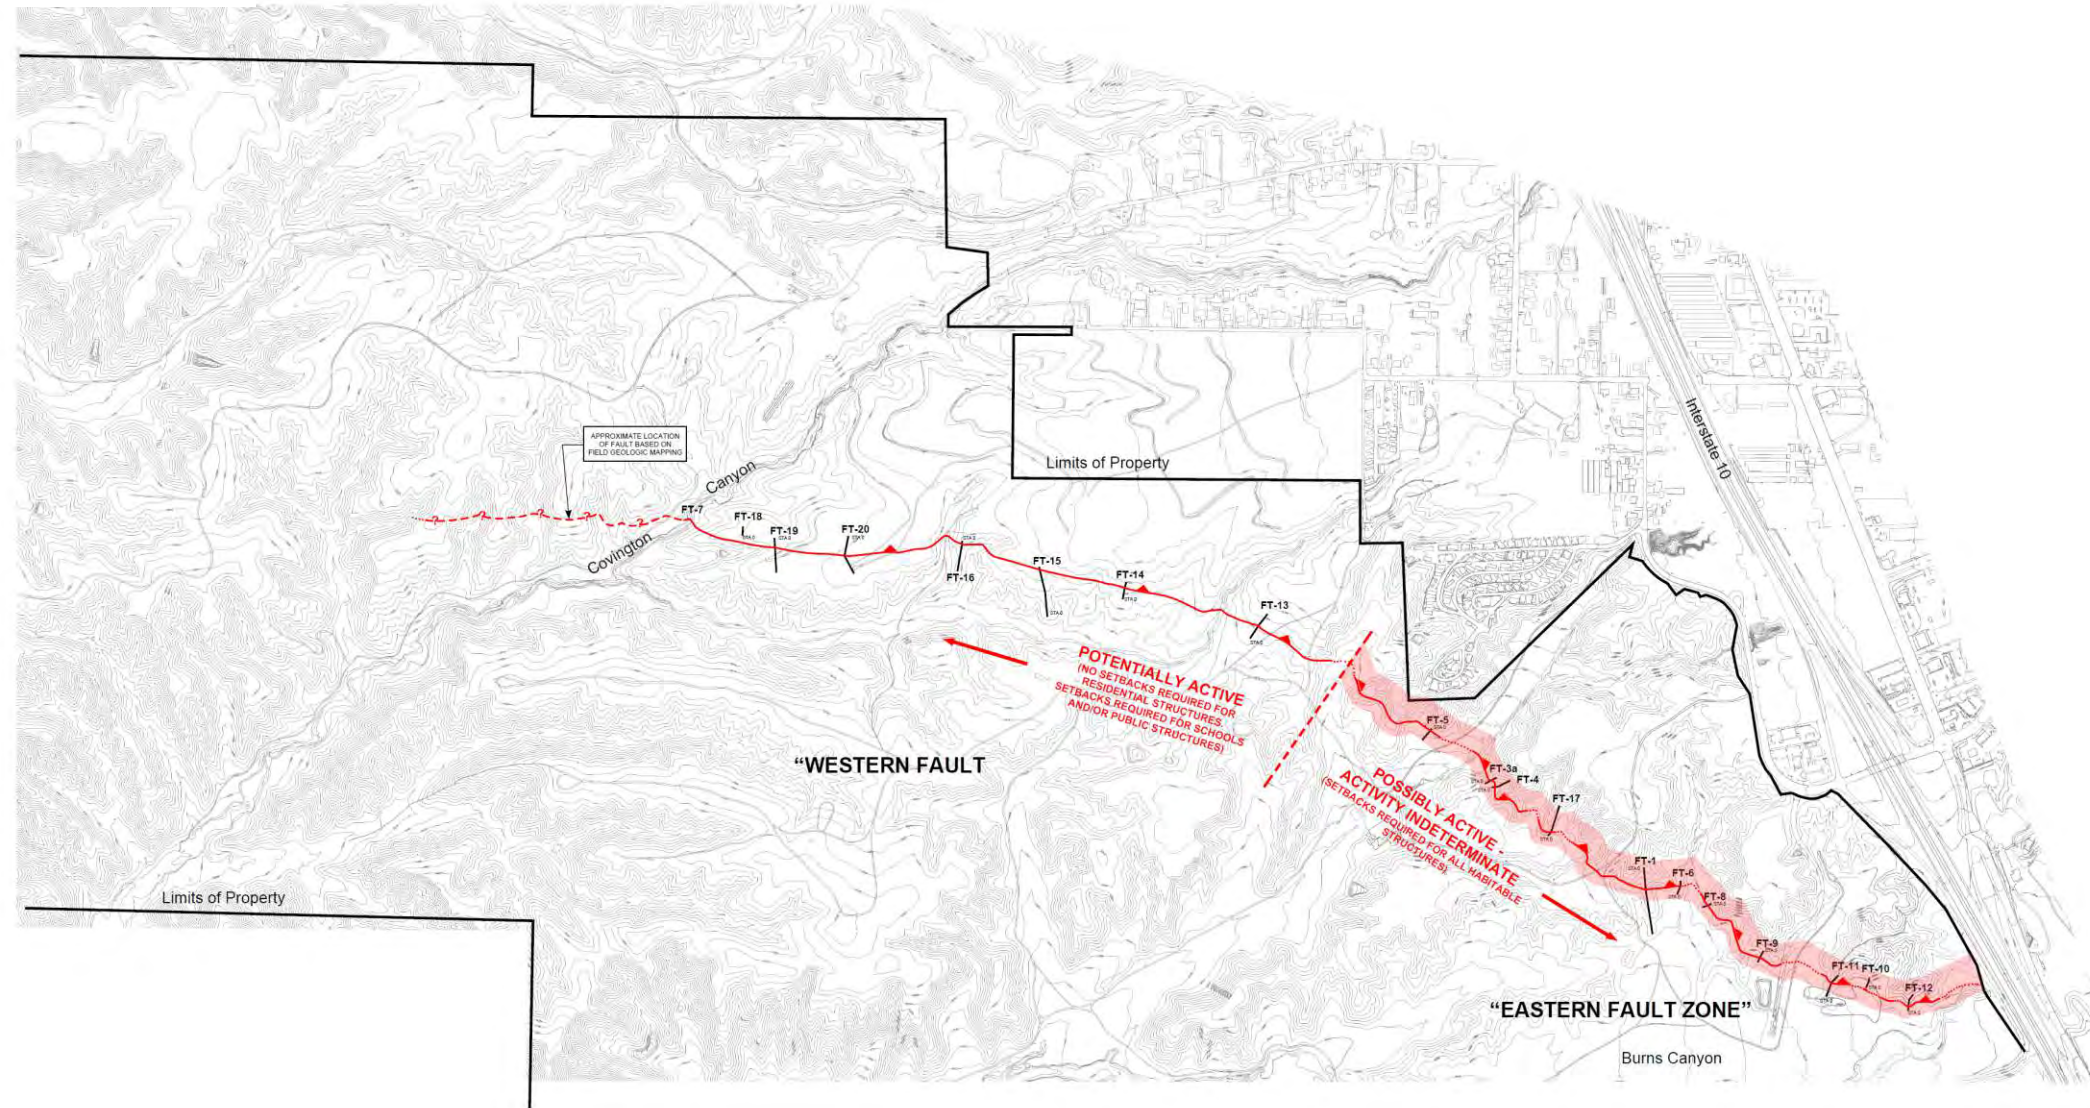
PETRA GEOSCIENCES, INC. 3186 Airway Avenue, Suite K Costa Mesa, California 92626 PHONE: (714) 549-8921 COSTA MESA TEMECULA VALENCIA PALM DESERT CORONA		
FAULT LOCATION AND SETBACK MAP		
Mesa Verde Project Calimesa, California

- Early Holocene faulting for the eastern portion of the site cannot be ruled out because slightly older sediments with ages closer to the Holocene/Pleistocene boundary are not present. Therefore, setbacks for habitable structures were recommended (see Figure 4).

- It was recommended that the setback zone on the hanging wall (north side of the fault) be at least 150 feet wide and the setback on the footwall (south side of the fault) be a minimum of 75 feet wide. These setbacks should be measured from the location of the mapped trace of the main strand of the fault (see Figure 4).

The Cherry Valley fault enters the southeast corner of the property from the east and extends northwesterly across the site. PGI/HAI, 2004, investigated the fault by excavating and logging 20 trenches across the fault and recommended a 150-foot setback northerly of the fault and a 75-foot setback southerly of the fault within the “Eastern Fault Zone” (see Figure 4). Setbacks for residential structures were not called for within the “Western Fault Zone”, however, fault setbacks would be required for schools and other public buildings (fire station, post office, etc.) along this portion of the fault. The location of the fault and the limits of the Restricted Building Zone are presented on Figure 4.

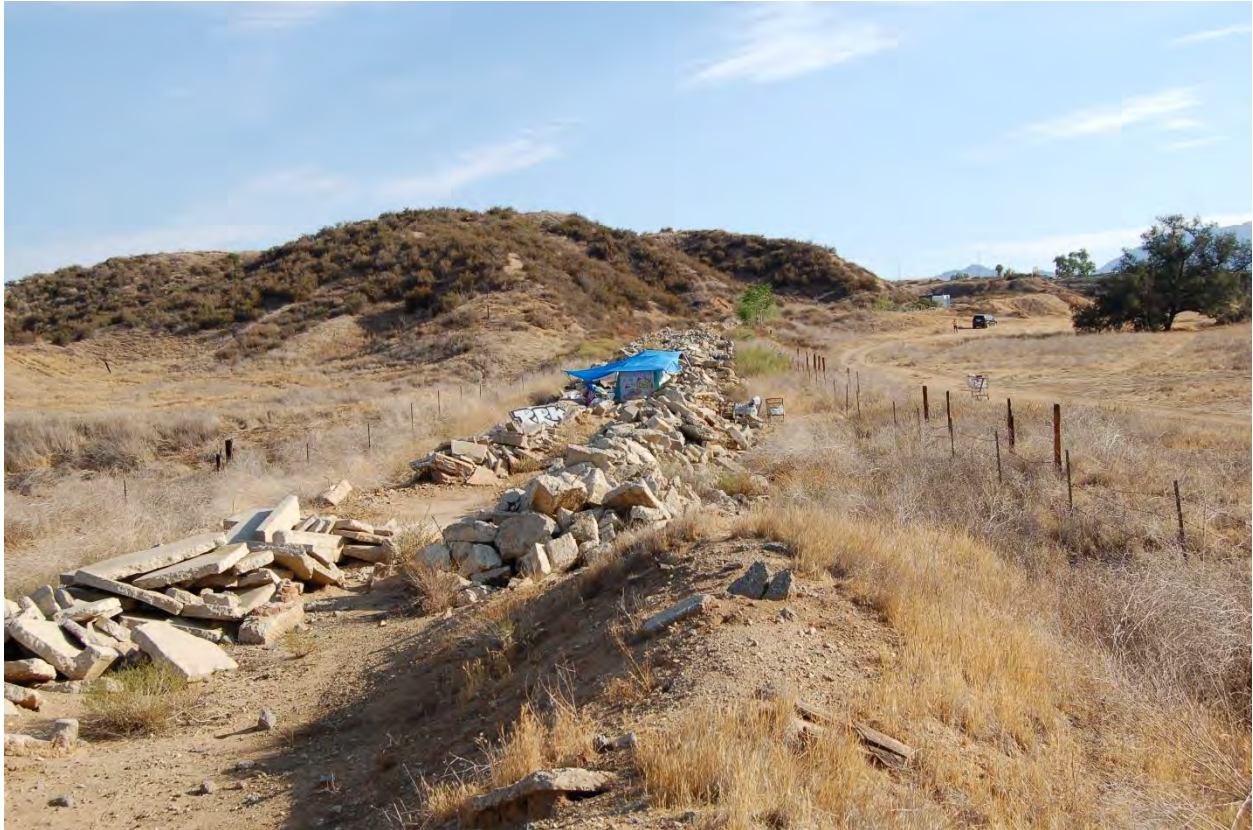
Photo #1 – North view of dumped concrete and homeless tent in the southeastern portion of the Site along Shady Brook Road.

- **Demolition, Clearing and Grubbing:** Prior to commencement of site grading activities, all existing trash, debris, site improvements, underground utility lines and/or structures (if encountered) will need to be demolished and removed from the site. In addition, the possibility may exist that other unknown underground structures may be found below current grades. It is recommended that all vegetation (including the root ball) encountered on site be removed and disposed in accordance with current local regulations.

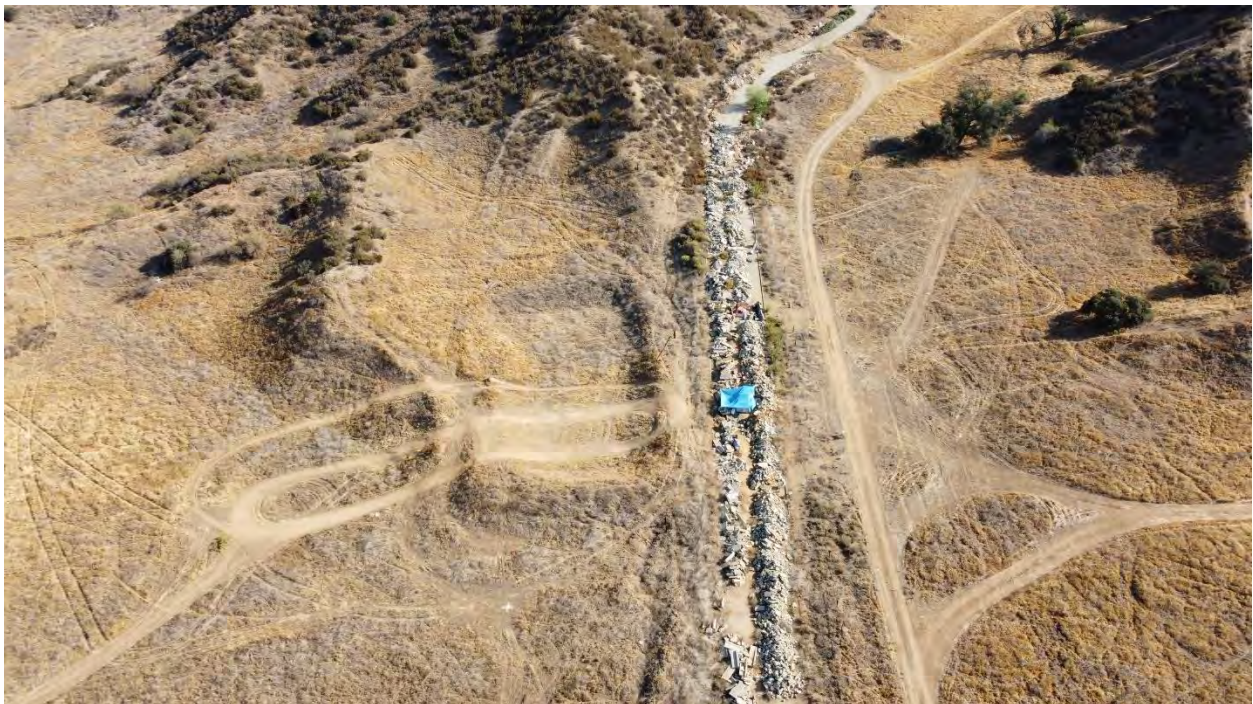
Photo #2 – Aerial view of basin and water well remnants west of Shady Brook Road in southeast portion of the Site.

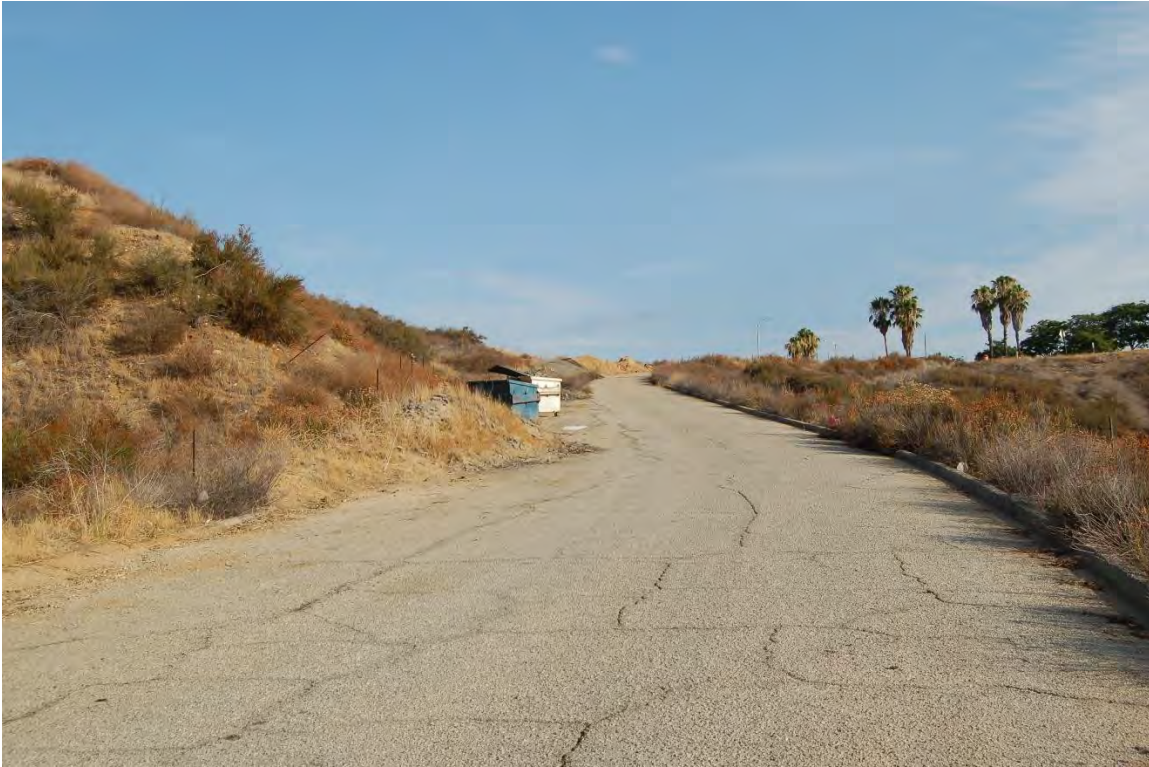
Photo # 3 – north view of upper portion of Shady Brook Road. Note stockpiled asphalt and soil in background behind trash bins.

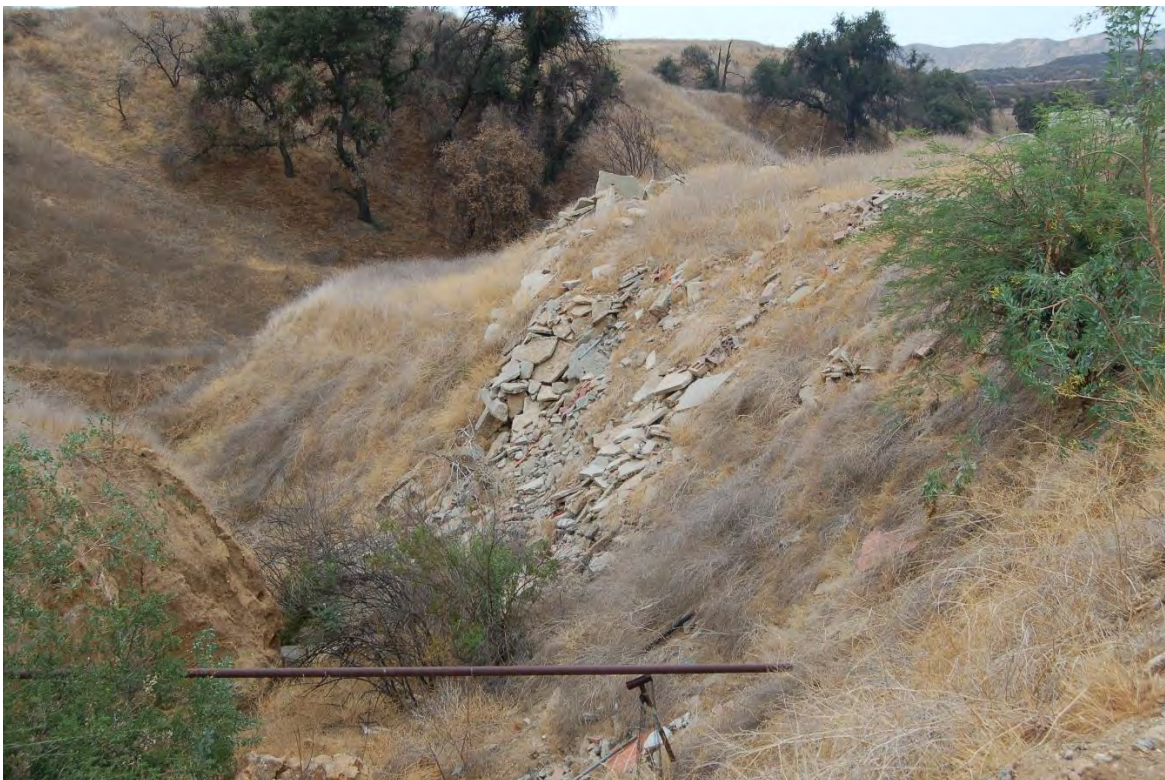
Photo # 4 – south view of dumped concrete, clay pipe, and brick in canyon south of the olive orchard in the northeastern portion of the Site. What appears to be a metal water line is visible in foreground.

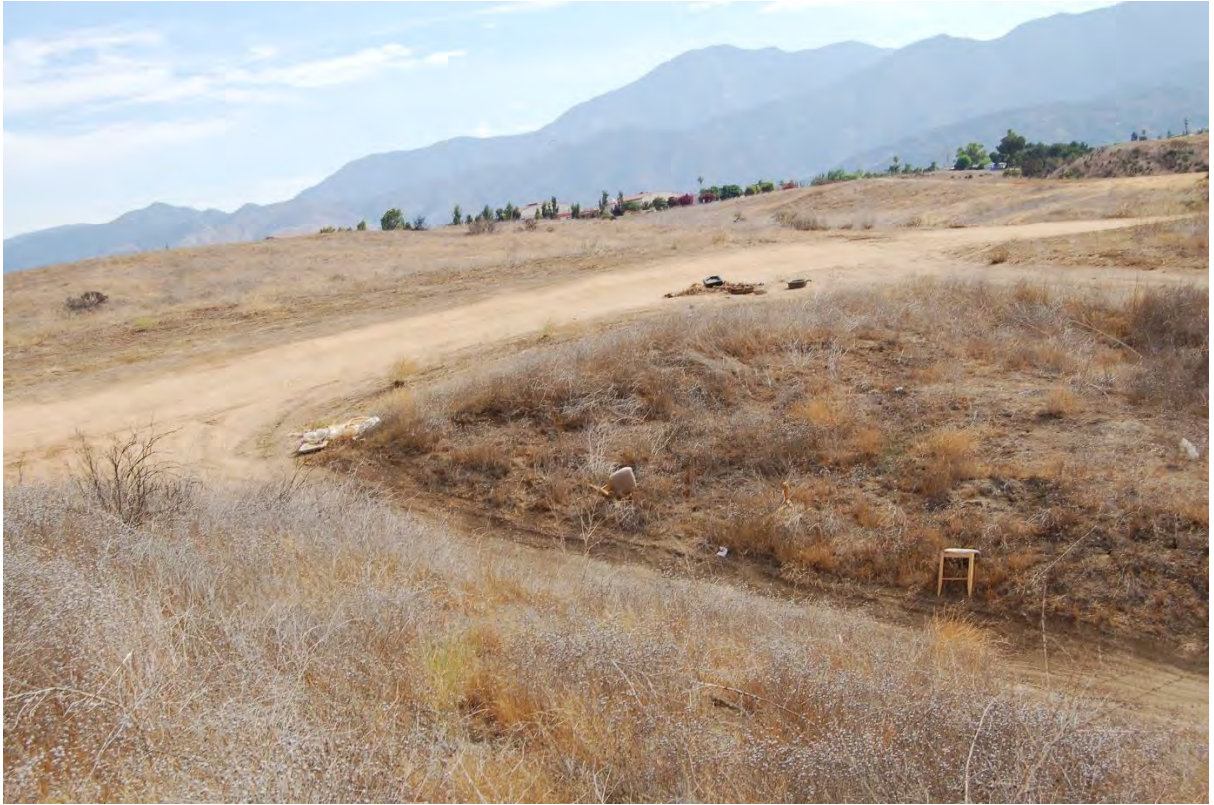
Photo # 5 – northerly view of dumped debris in east portion of Site. School is visible in background.

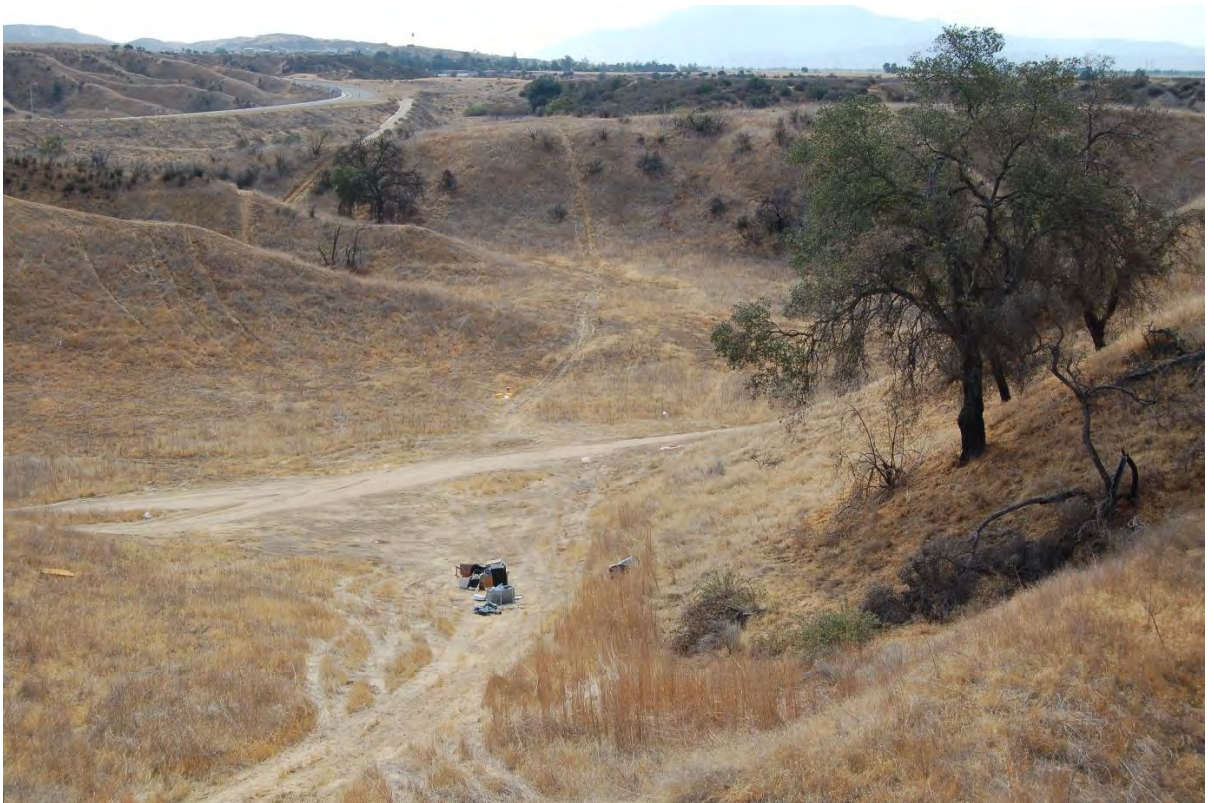
Photo # 6 – east view of dumped household debris in eastern portion of the Site. Sandalwood Drive visible in left background.

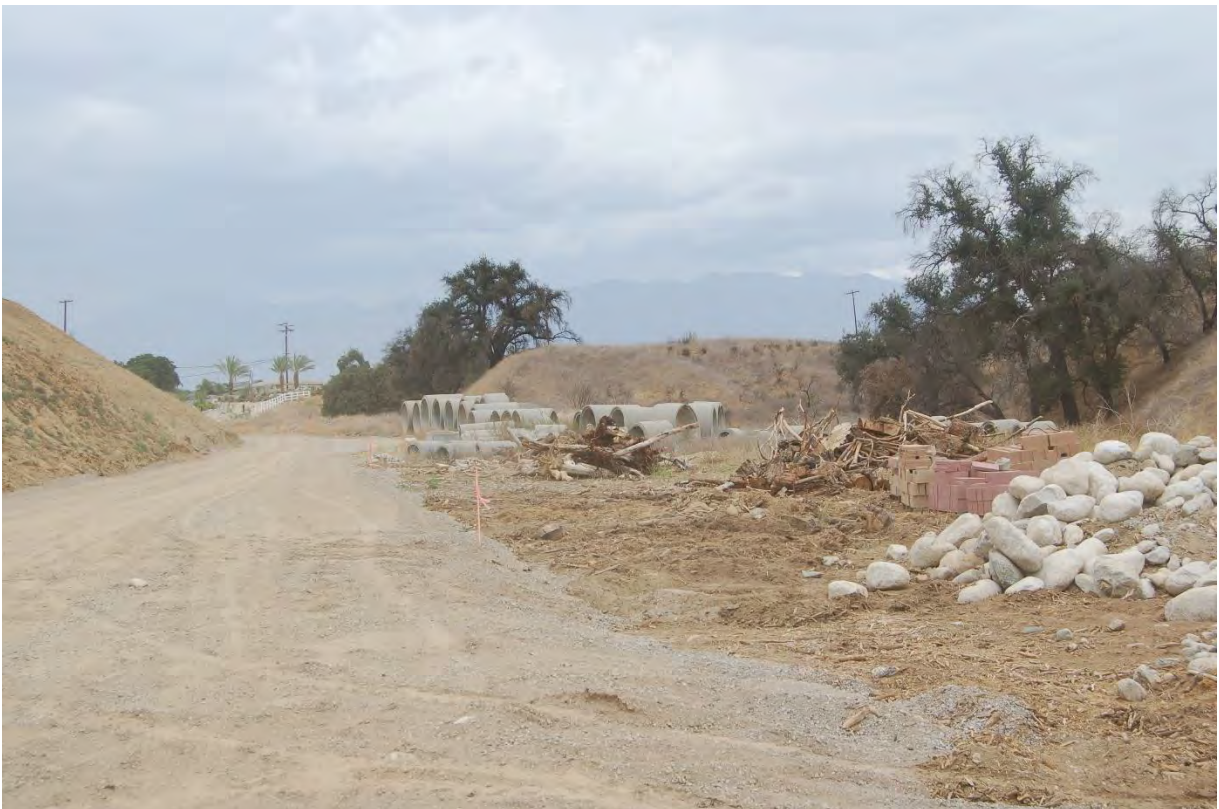
Photo # 8 – Stockpiled concrete pipe, brick, cobbles and general debris along dirt road below trailer park.

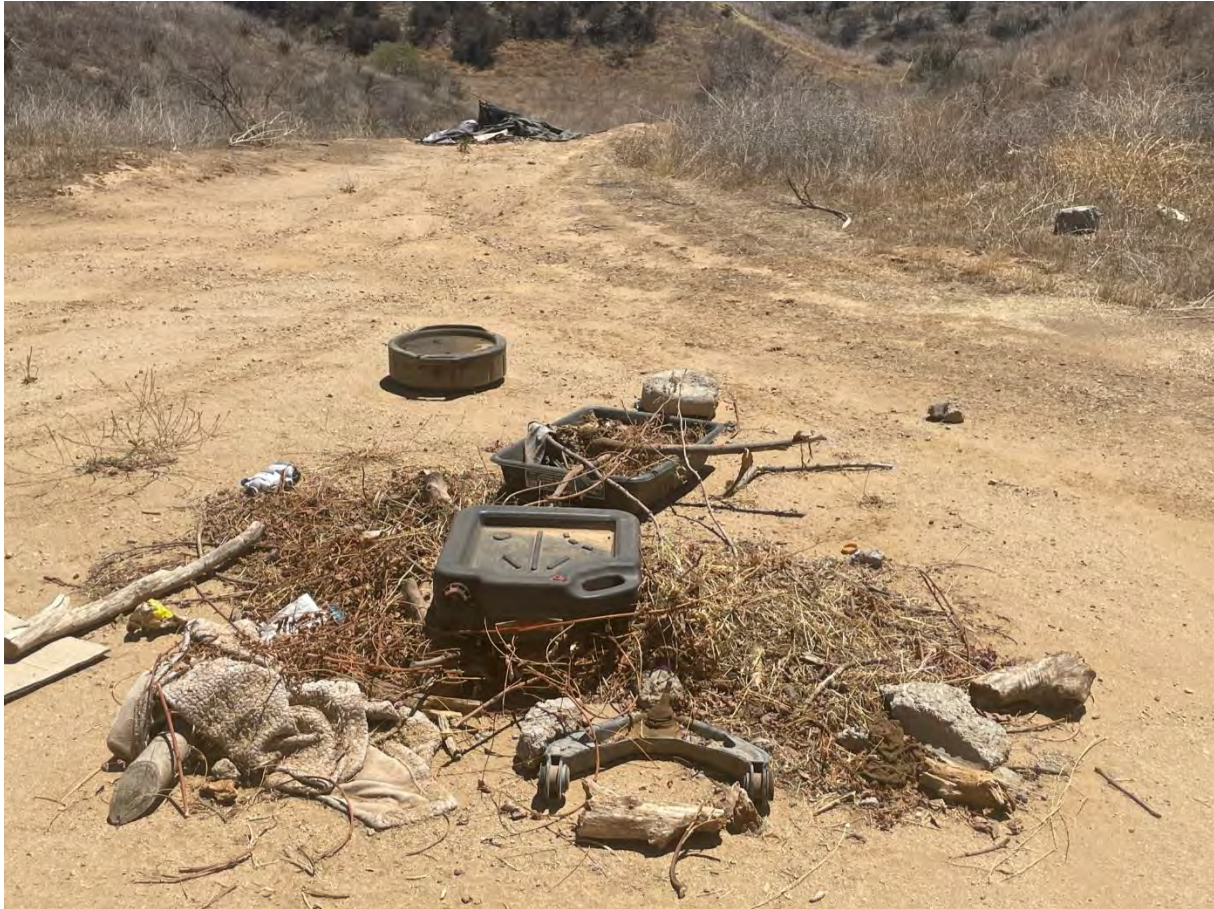
Photo # 13 – dumped debris along dirt road in central portion of the Site. Note waste oil containers.

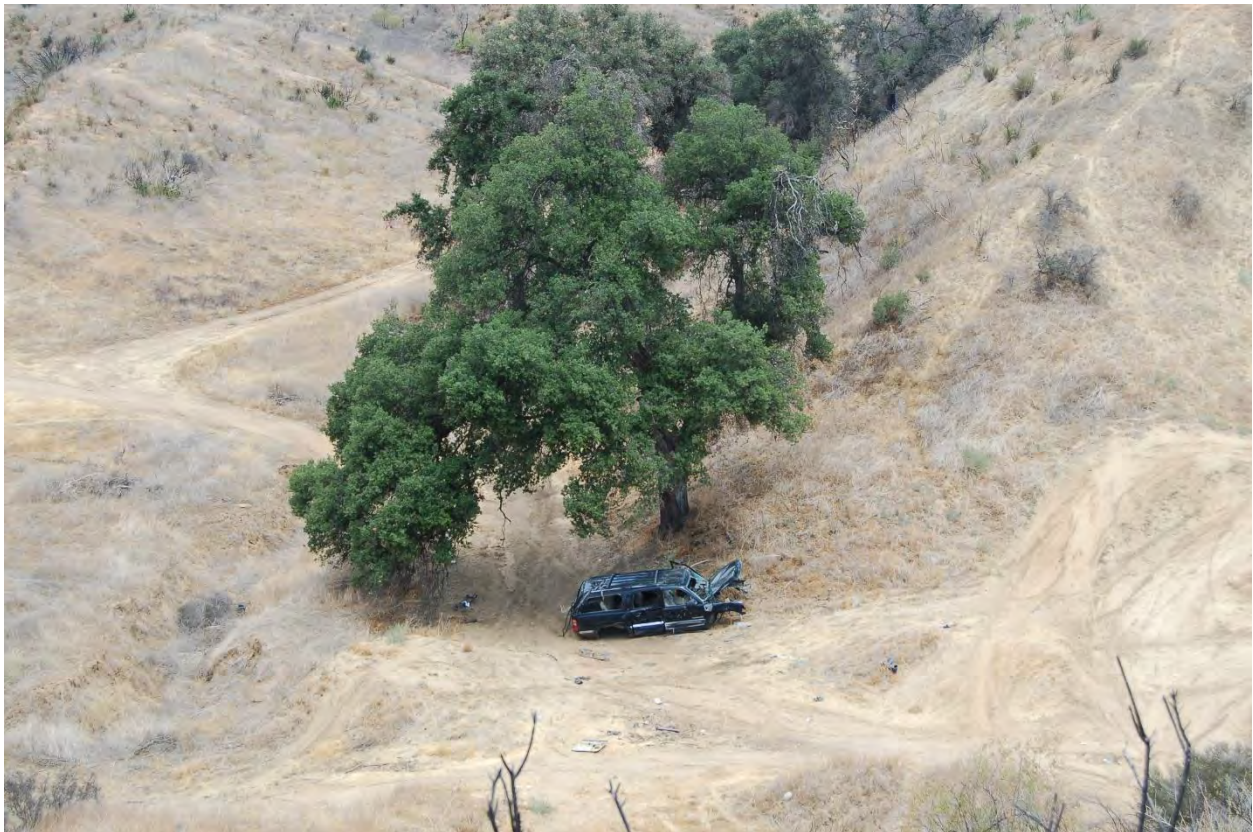
Photo # 16 – abandoned vehicle in canyon area within eastern portion of the Site.

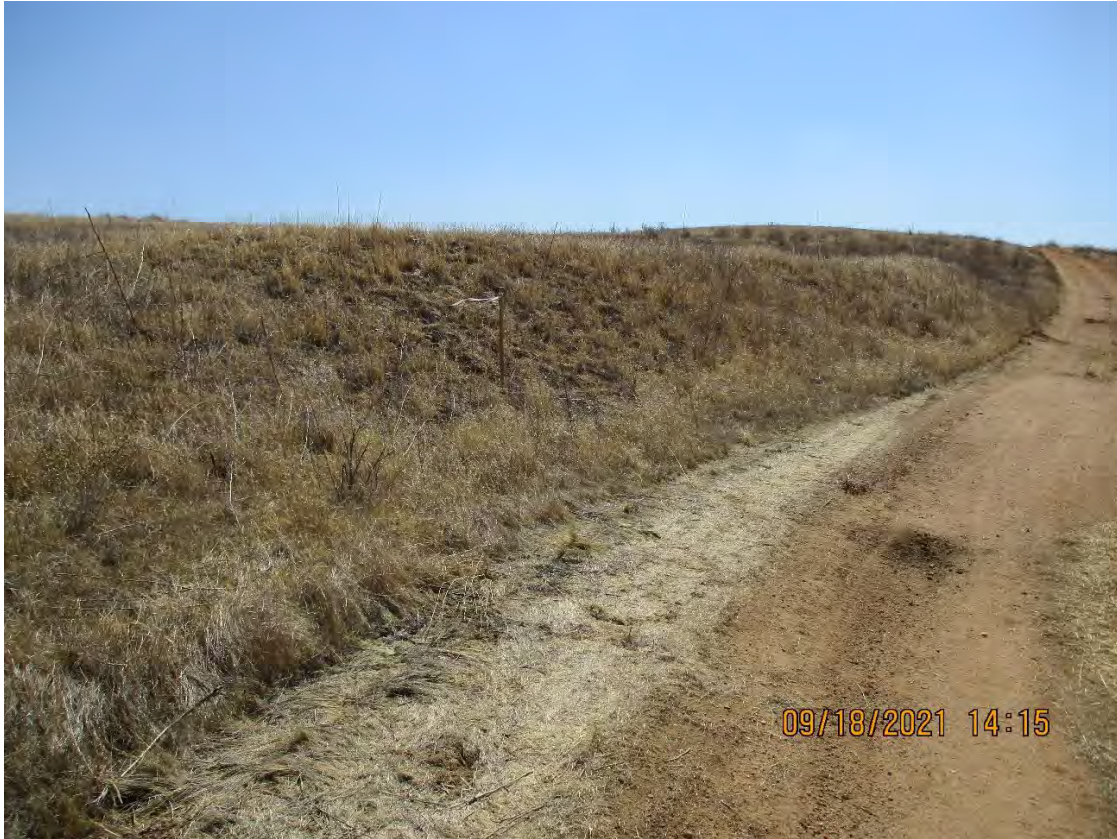
Photo # 19 – southerly view of slope associated with oil well sump in west central area of property.

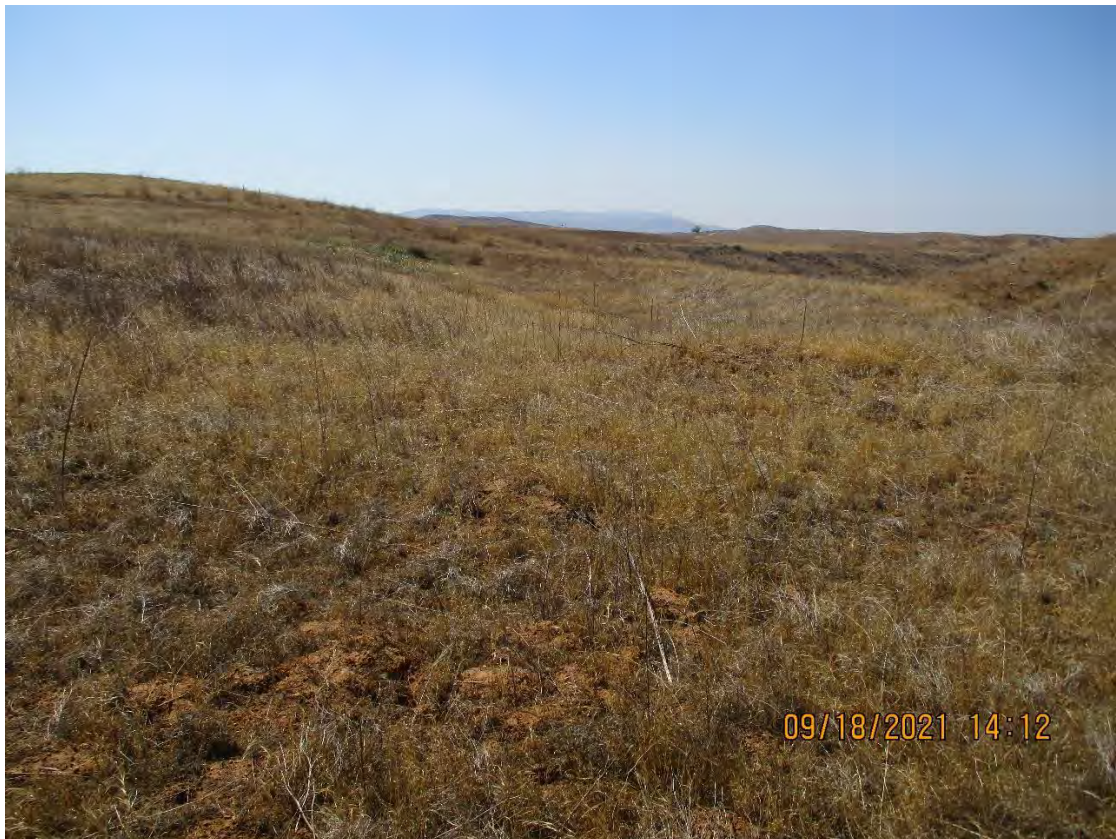
Photo # 20 – westerly view of oil well sump in west central area of property.
